Delivery Order 9 Enhanced Preliminary Assessment

FORT BENJAMIN HARRISON, INDIANA

February 1992

USATHAMA DELIVERY ORDER 9
ENHANCED PRELIMINARY ASSESSMENT
FORT BENJAMIN HARRISON
INDIANA

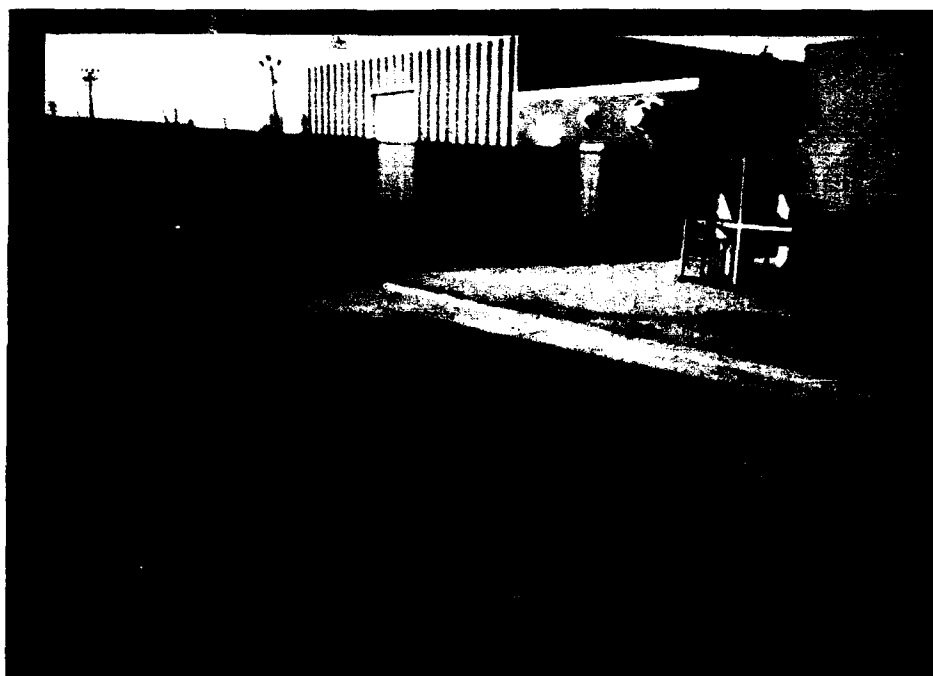
**8. WASH RACK, U.S. ARMY RESERVE CENTER
(BUILDING 127)**

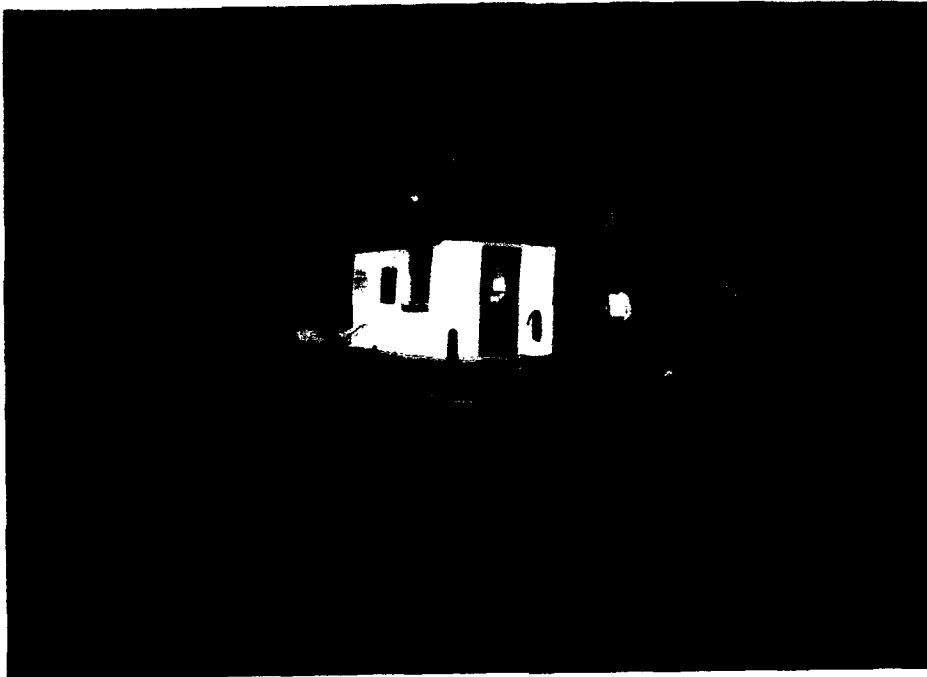
**13. POL FUELING STATION WITH USTs,
(BUILDING 239)**

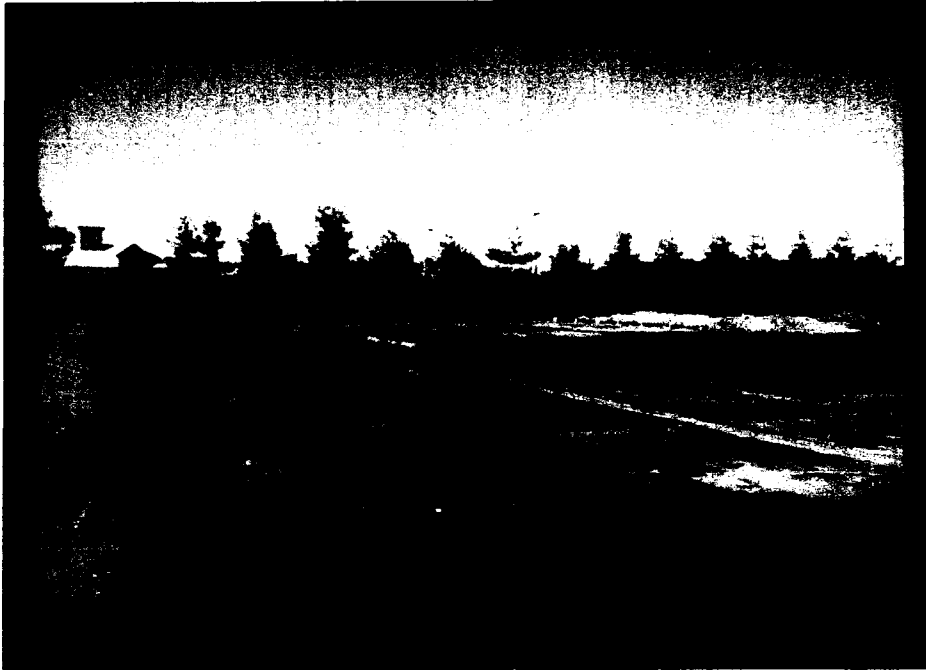
**28. AMMUNITION STORAGE AREA
(BUILDING 520)**
